Center for Nondestructive Evaluation

Zerstörungsfreie Charakterisierung der Degradation von Werkstoffen und Bauteilen im Einsatz

Nach wie vor eine Herausforderung für konventionelle und
moderne Werkstoffe zur Anwendung im Leichtbau

Norbert Meyendorf

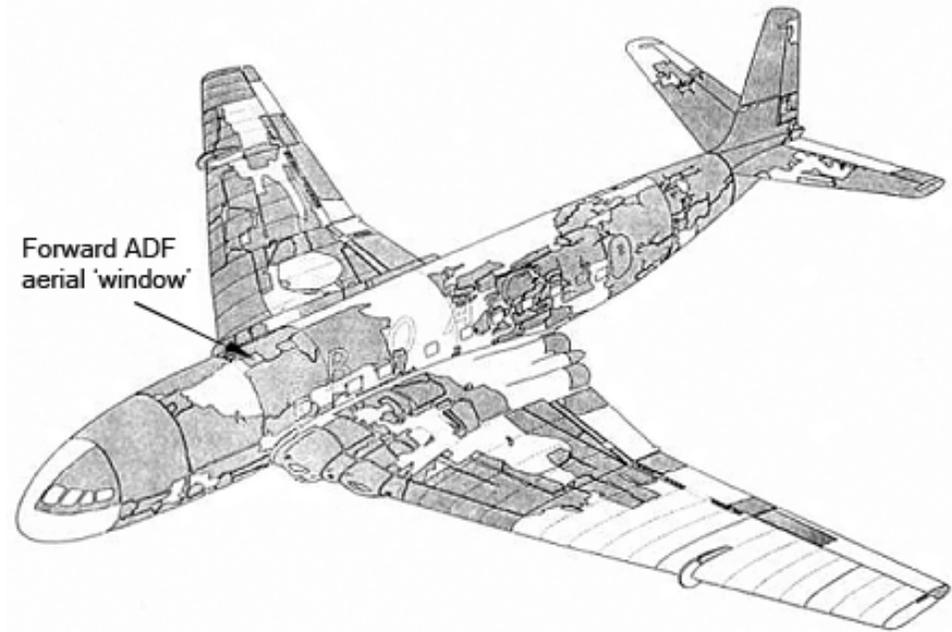
Two de Havilland Comet passenger jets broke up in mid-air and crashed within a few months of each other in 1954. As a result, systematic tests were conducted on a fuselage immersed and pressurized in a water tank. After the equivalent of 3,000 flights investigators at the Royal Aircraft Establishment (RAE) were able to conclude that the crash had been due to **failure of the pressure cabin at the forward Automatic Direction Finder window in the roof**. This 'window' was in fact one of two apertures for the aerials of an electronic navigation system in which opaque fiberglass panels took the place of the window 'glass'. **The failure was a result of metal fatigue caused by the repeated pressurization and de-pressurization of the aircraft cabin.**

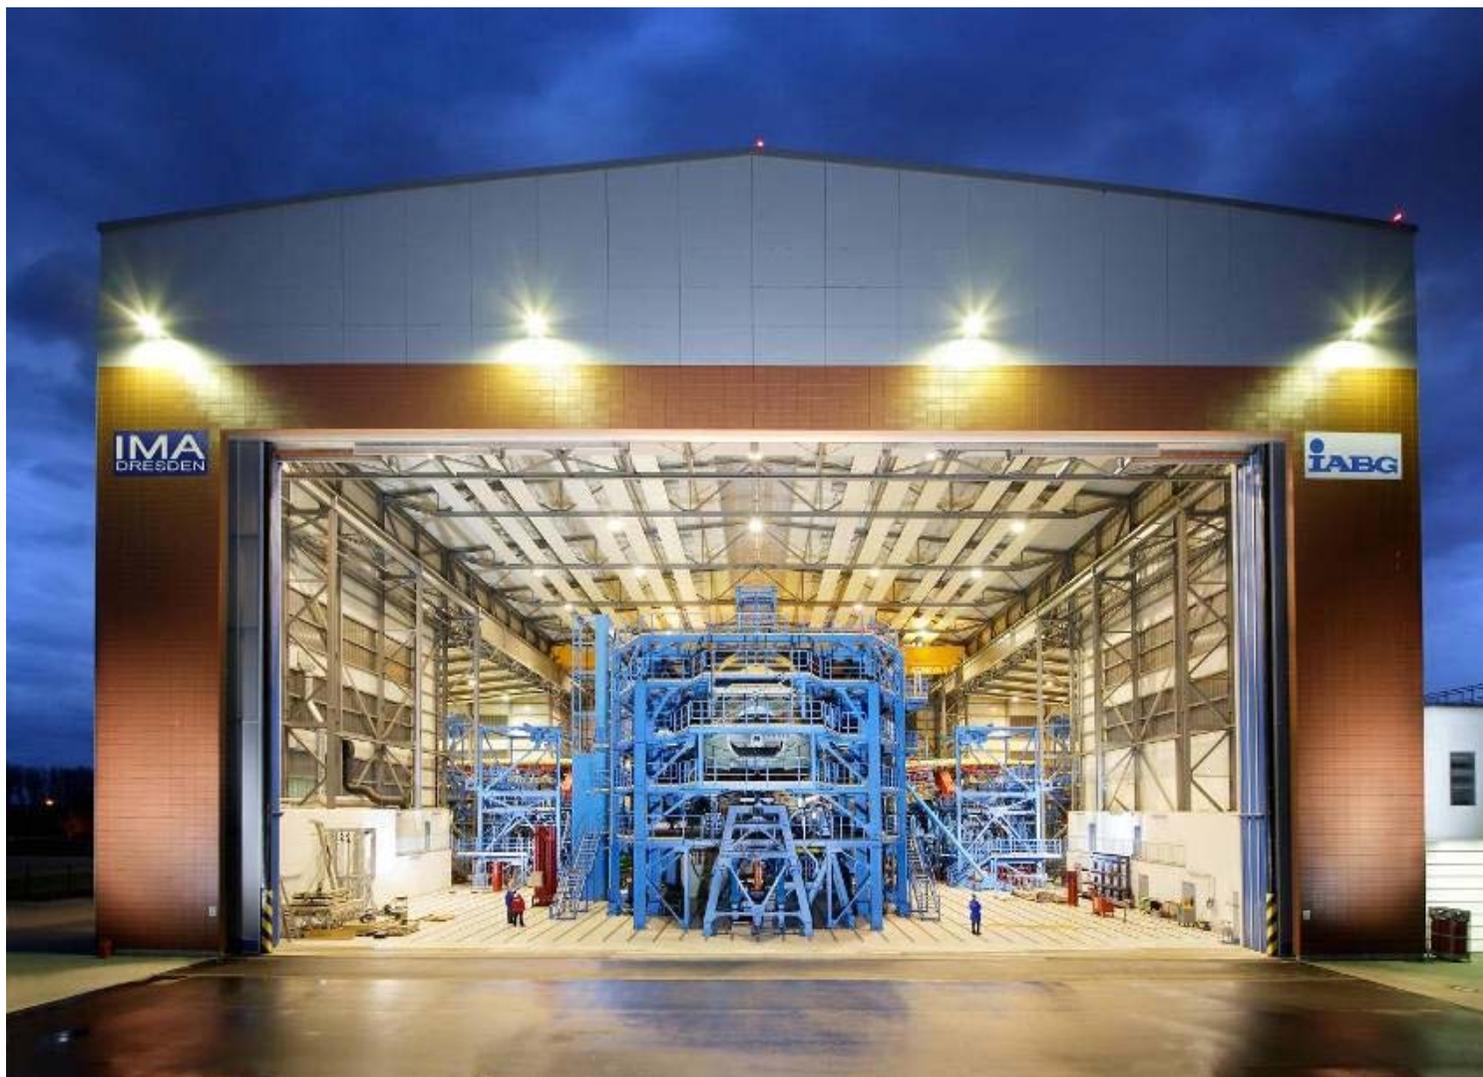
Airbus A380 Full Scale Fatigue Test

Schwarberg, IABG Dresden

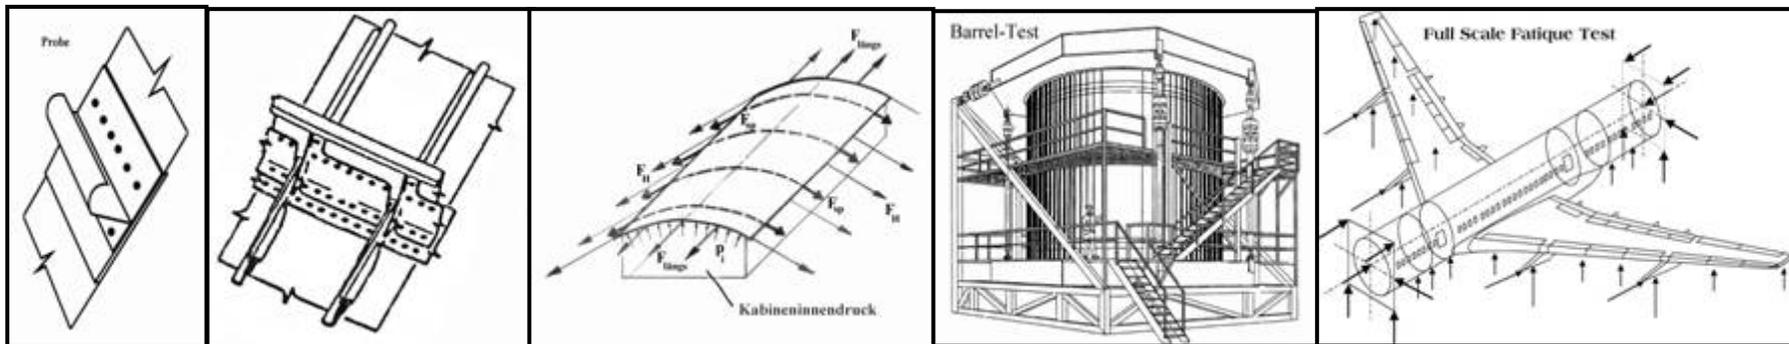
The introduction of new materials and technologies requires a multitude of investigations and verifications known as testing pyramid starting with coupons and components to complete aircraft structures. Static and dynamic properties are examined

Coupon test

Panel test

Curved Panel test

Barrel test

Full scale fatigue test

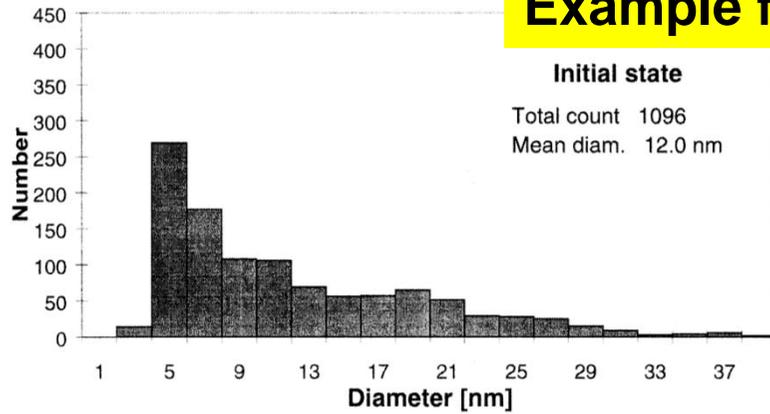
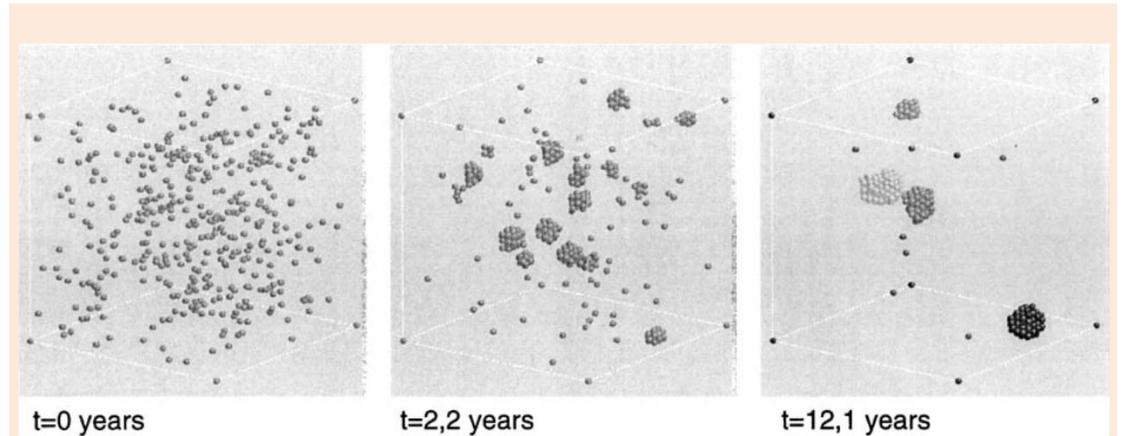
Results of a Monte Carlo simulation on formation and growth of copper precipitates; only the copper, not the iron atoms are shown.

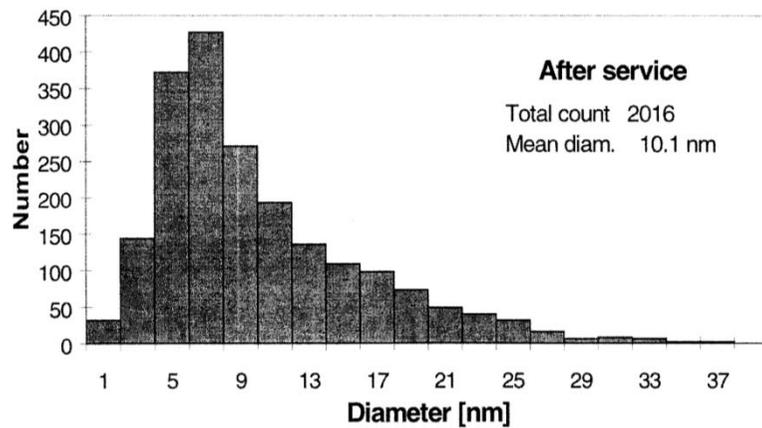
WB 36 — size distribution of the copper precipitates.

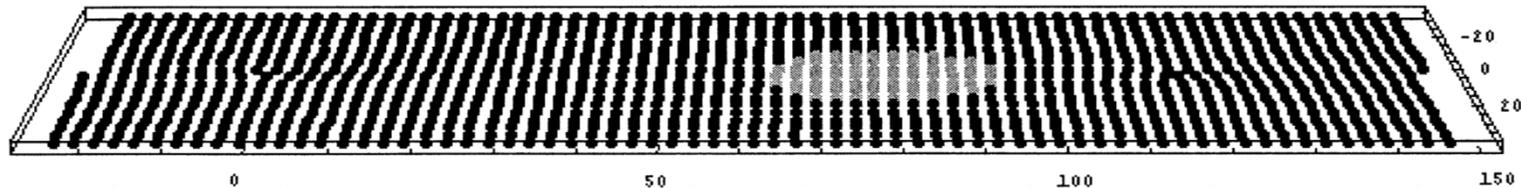
Cross-section through the iron structure model used for the nano-simulation of the dislocation movement; scale in 1Å, (0.1nm).

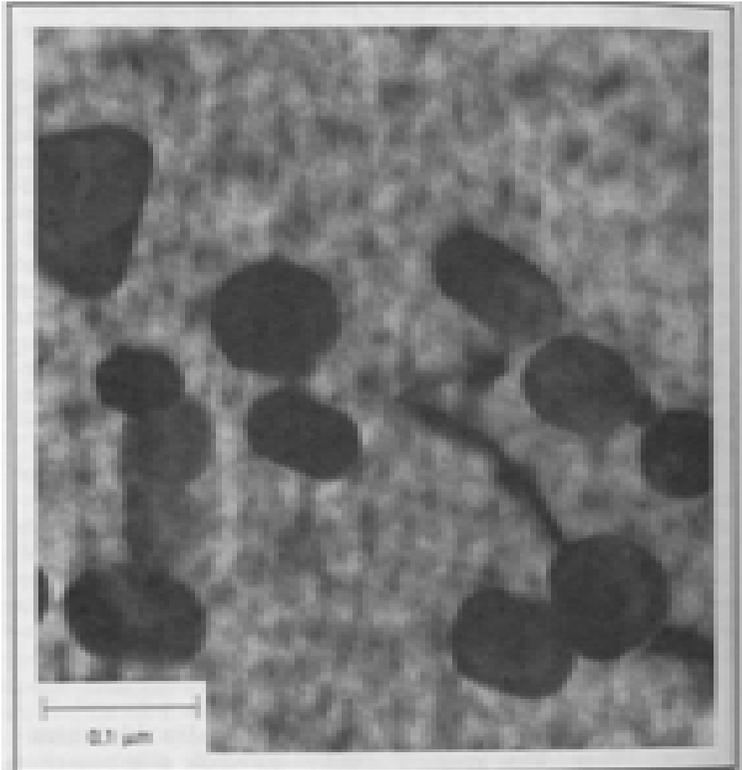
Fig. 7. Transmission electron micrograph of 7075-T6 aged 25 years at room temperature. The large particles are Al_2Mg_2Cr dispersoid. The GP zones throughout the structure have an average diameter of 1.2 nm (12 Å), and an approximate density of 4×10^{17} zones per cm^3 . The yield strength of the unaged 7075-T6 was 150 MPa (22 ksi). After 25 years, yield strength had increased to 460 MPa (67 ksi).

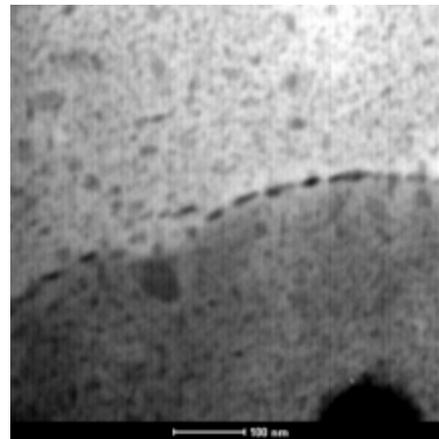
Fine phase precipitates

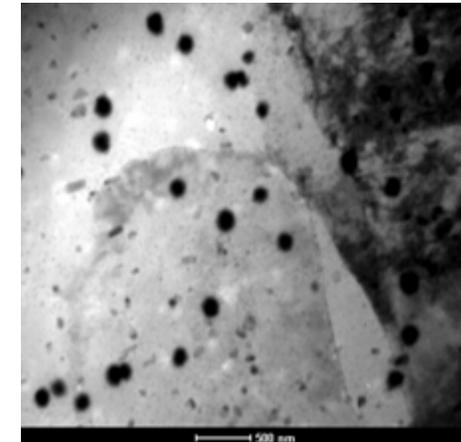
Coarse phase precipitates

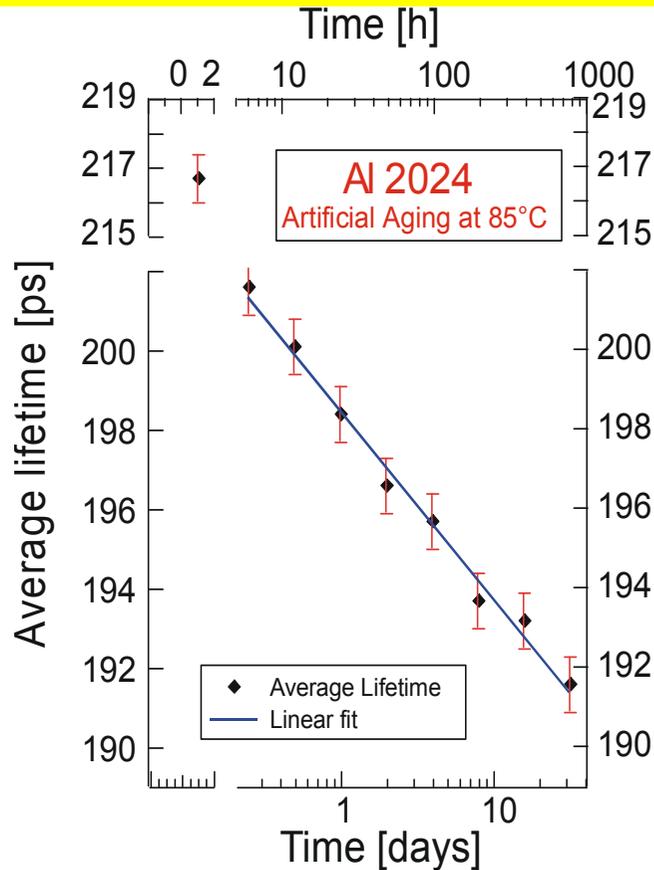
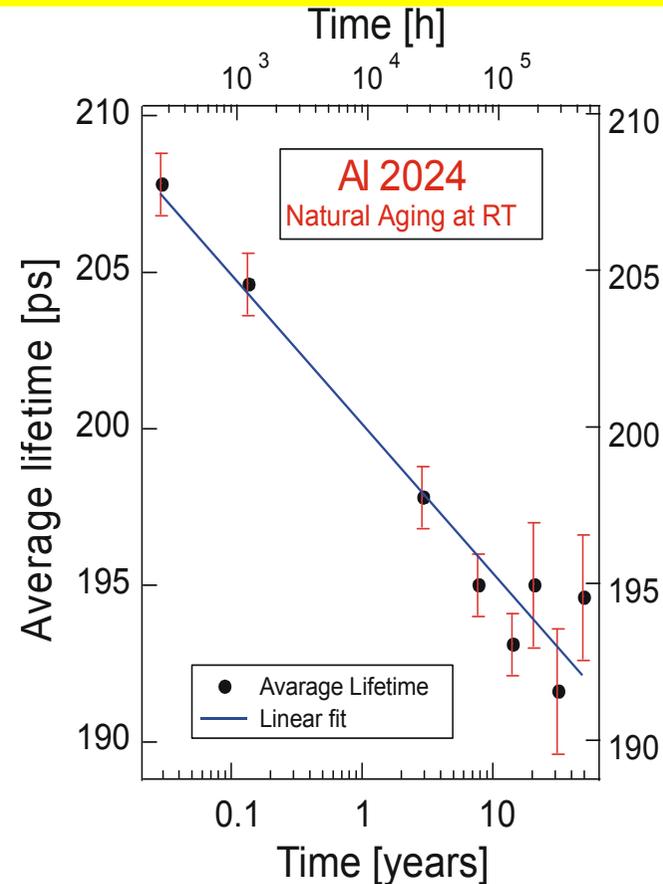
Aging of Aluminium Alloys: Positron Lifetime Data

Increase of Cu content in GP zones => positron lifetime decreases

- Exponential change of positron lifetime
- Change in chemical composition and microstructure (GP2 zones)

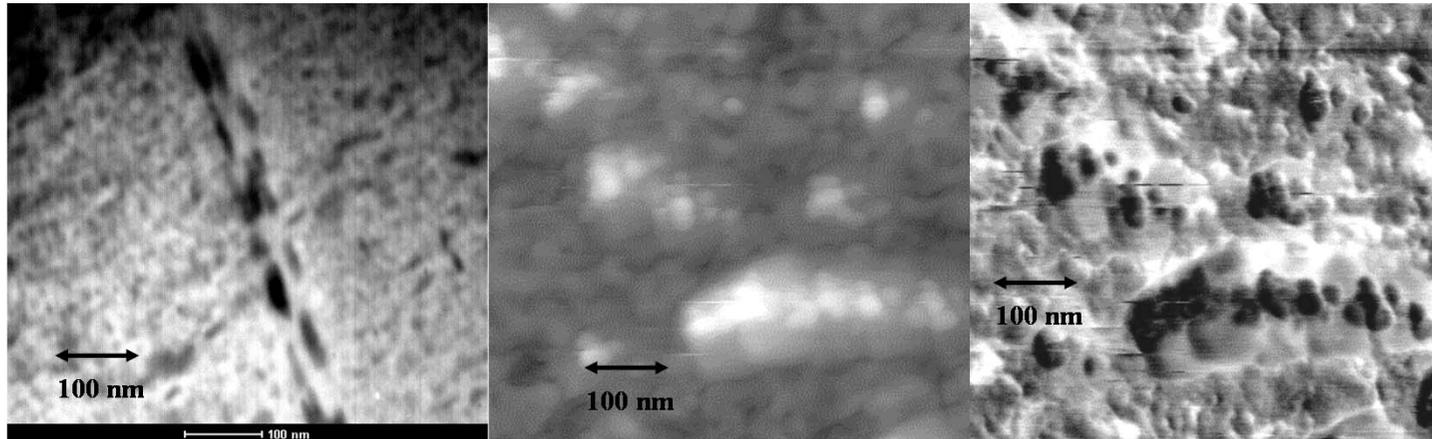
TEM

AFM

UFM

Images of material after 40 minutes RRA time.

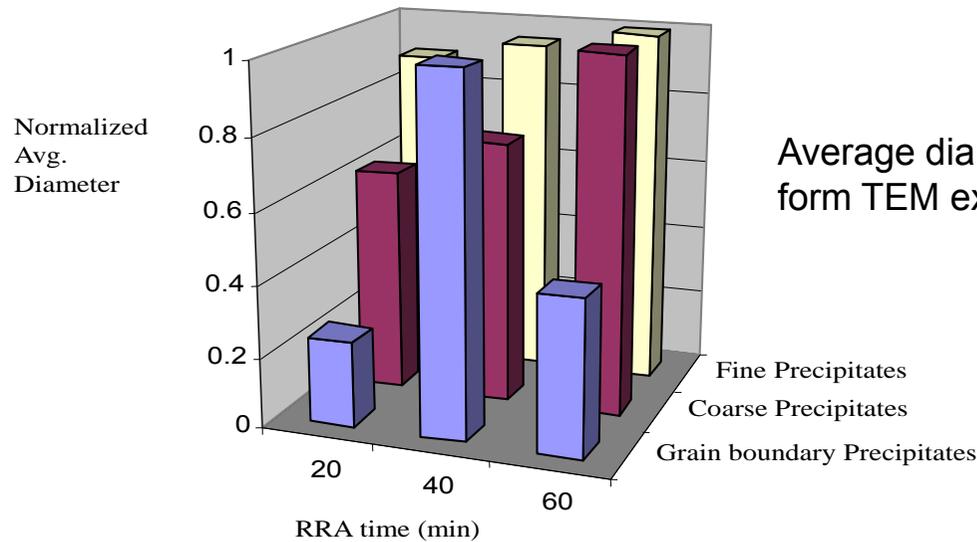
Average diameter of precipitations from TEM experiment

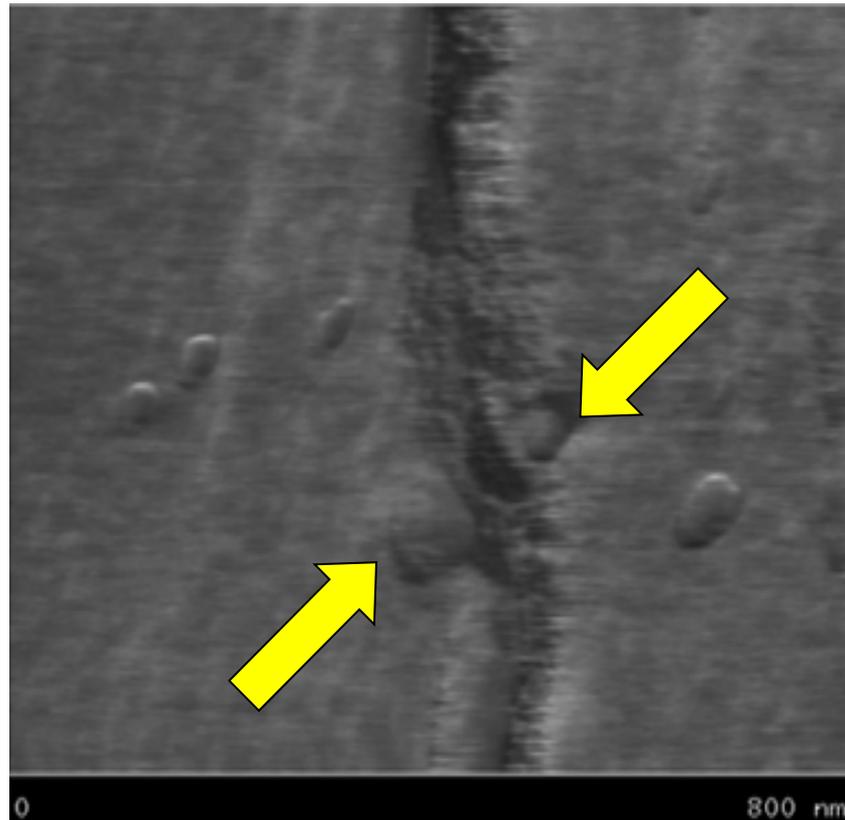
Scan size 800 nm, transducer frequency 478.3 kHz

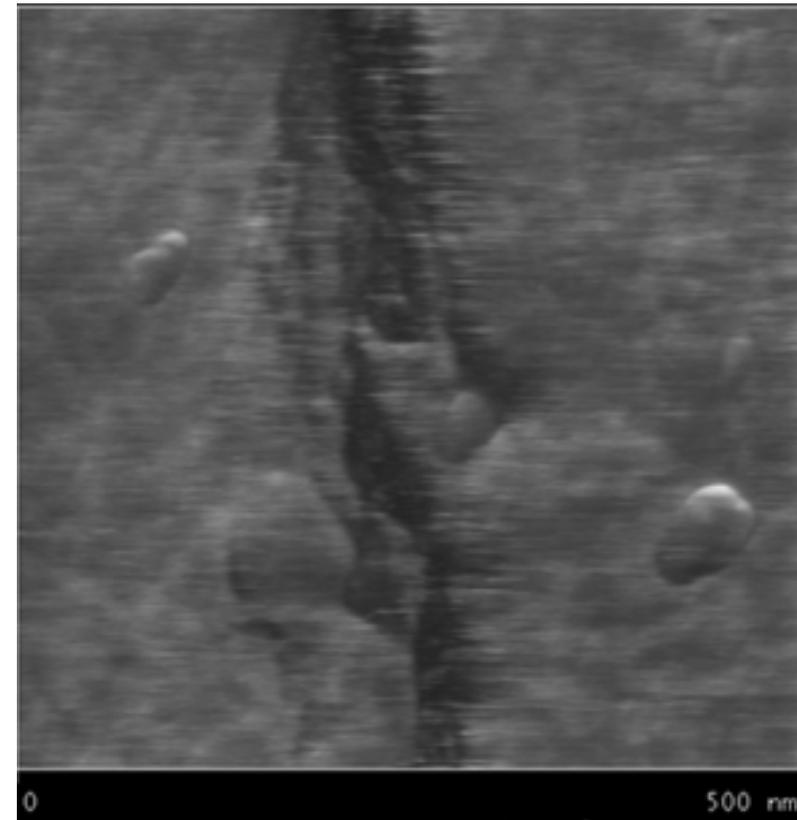
Scan size 500 nm, transducer frequency 146.3 kHz

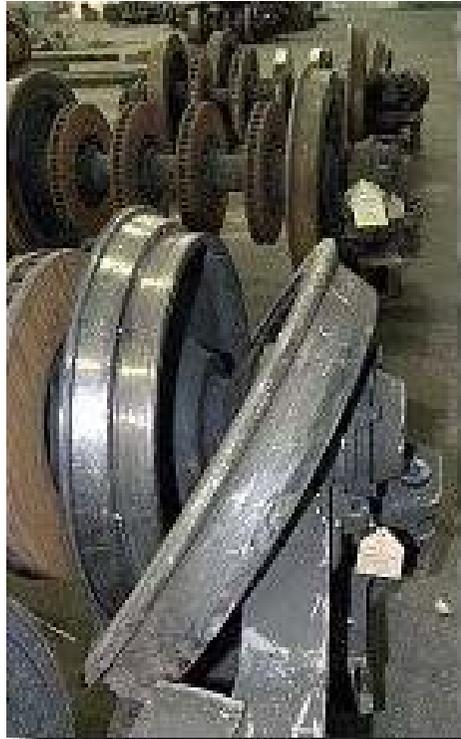
Crack in wheel rim

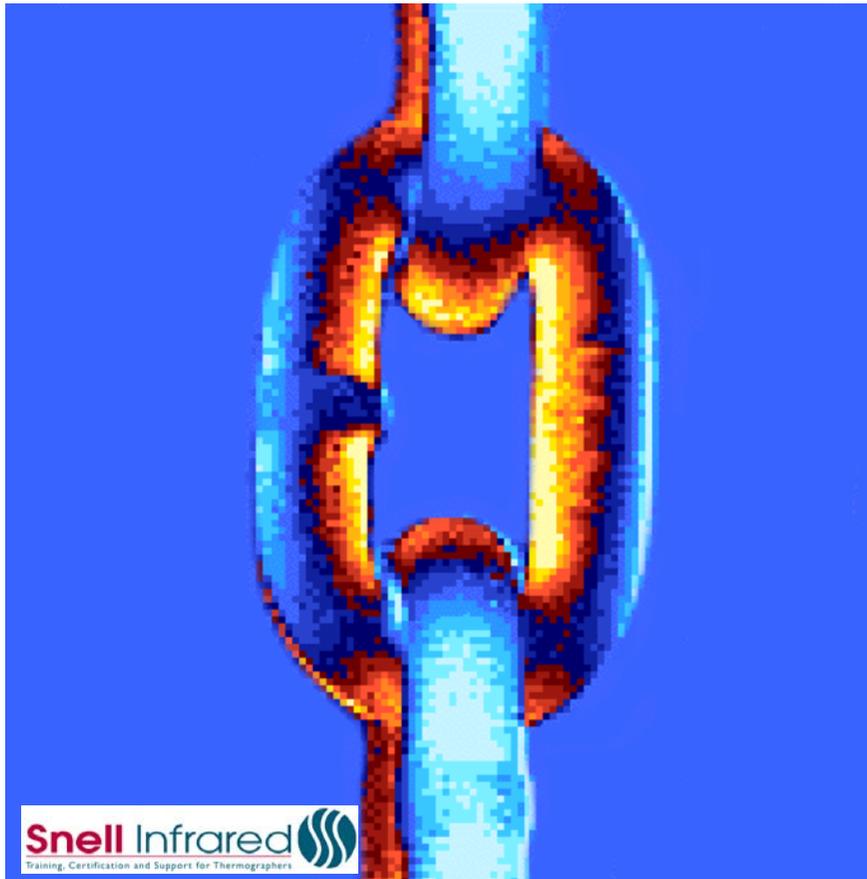
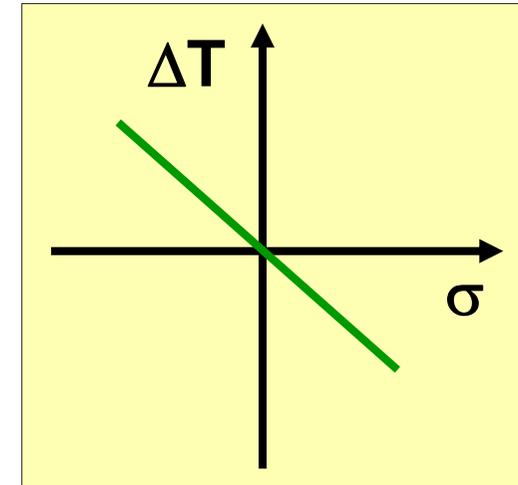
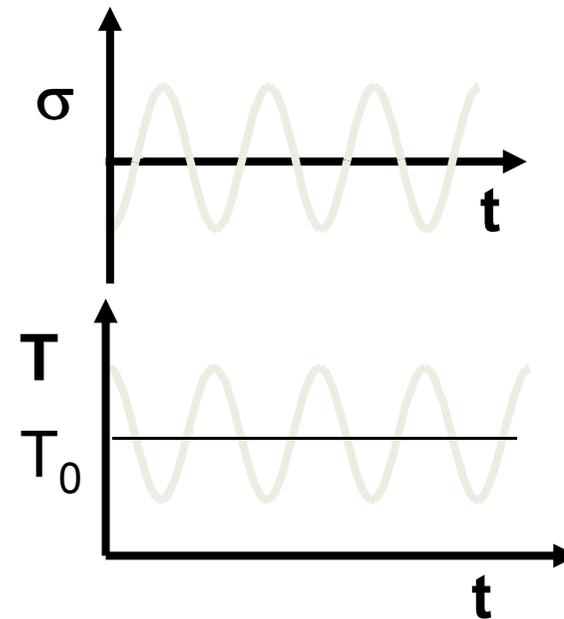
Thermoelastic Effect

DeltaTherm 1000 image of the stresses in a chain link loaded at 10Hz.

Image acquisition time: 30s.

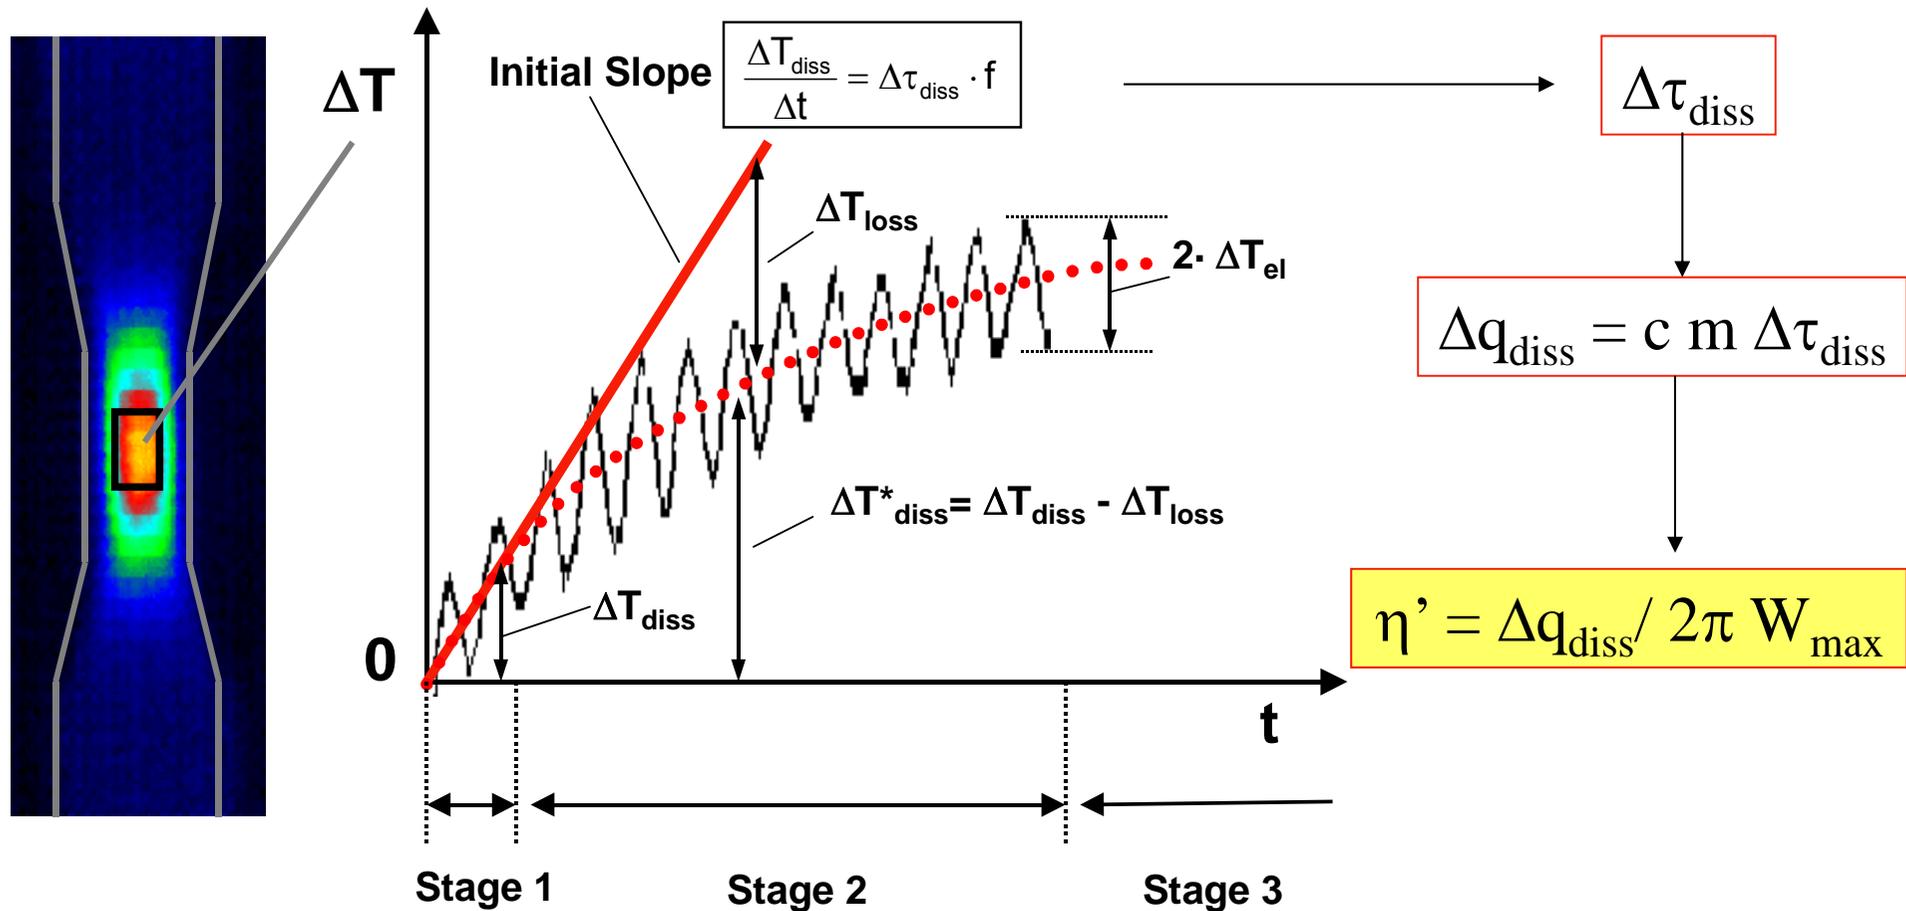
Temperature Due to Mechanical Loading & Evaluation of The Initial Slope

$$\Delta T(t) = T(t) - T_0 = \Delta T_{el}(t) + \Delta T_{diss}(t) + \Delta T_{loss}(t)$$

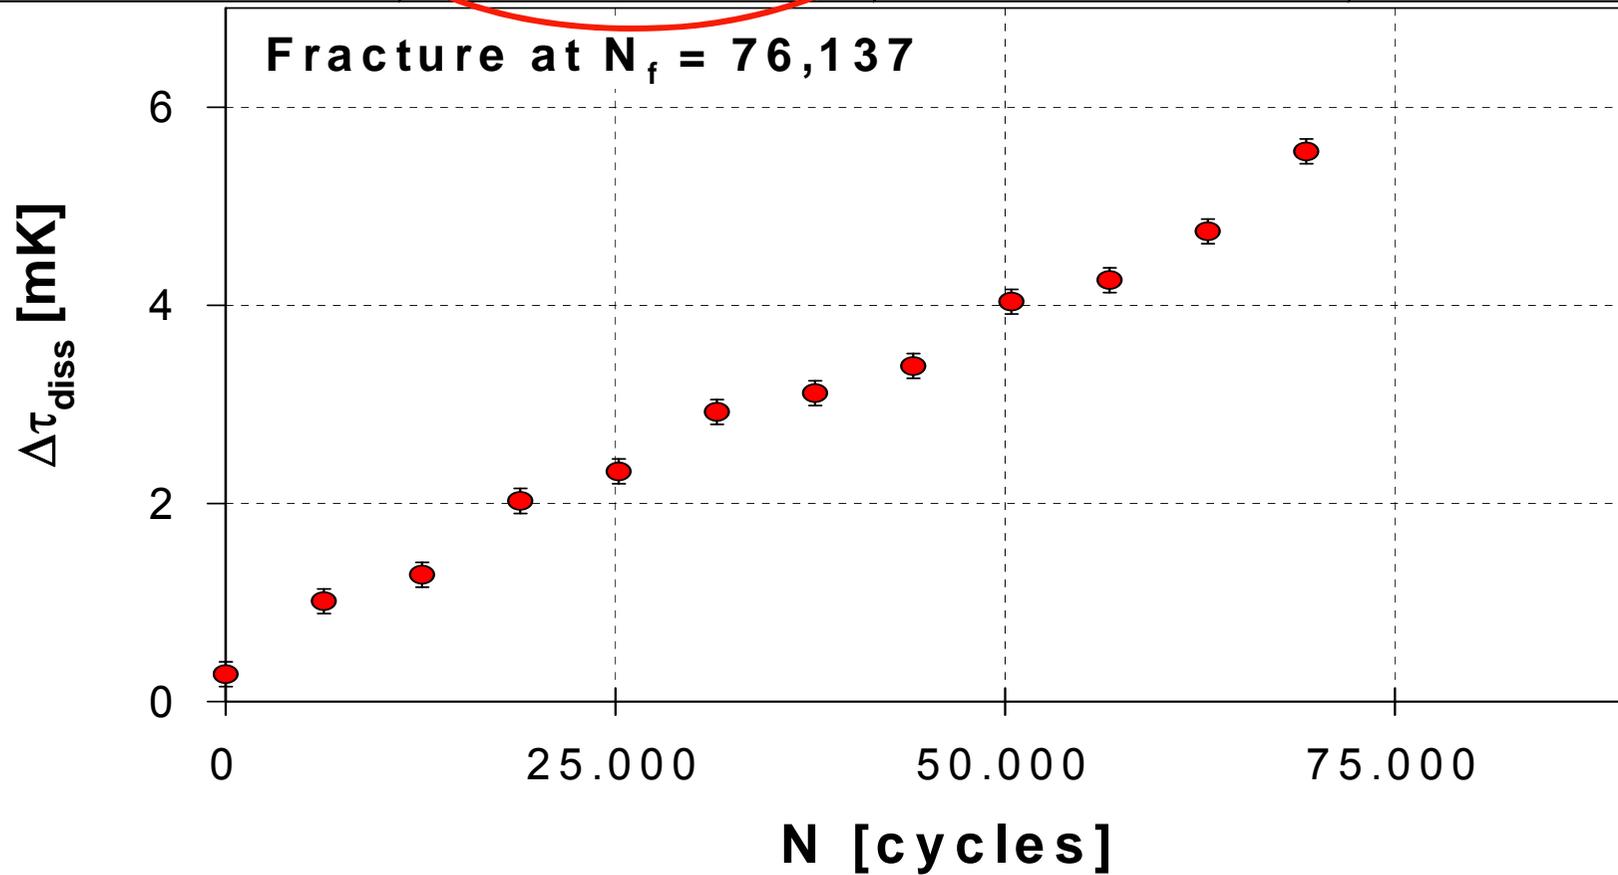
FATIGUE Ti-6Al-V4 LOW FREQUENCY EXCITATION

Mechanical Loading	Power Ultrasonics	Nonlinear Acoustics
Loading frequency	30 Hz	20 kHz	10 MHz
Max. Stress	500 MPa	50 MPa	0.5 MPa

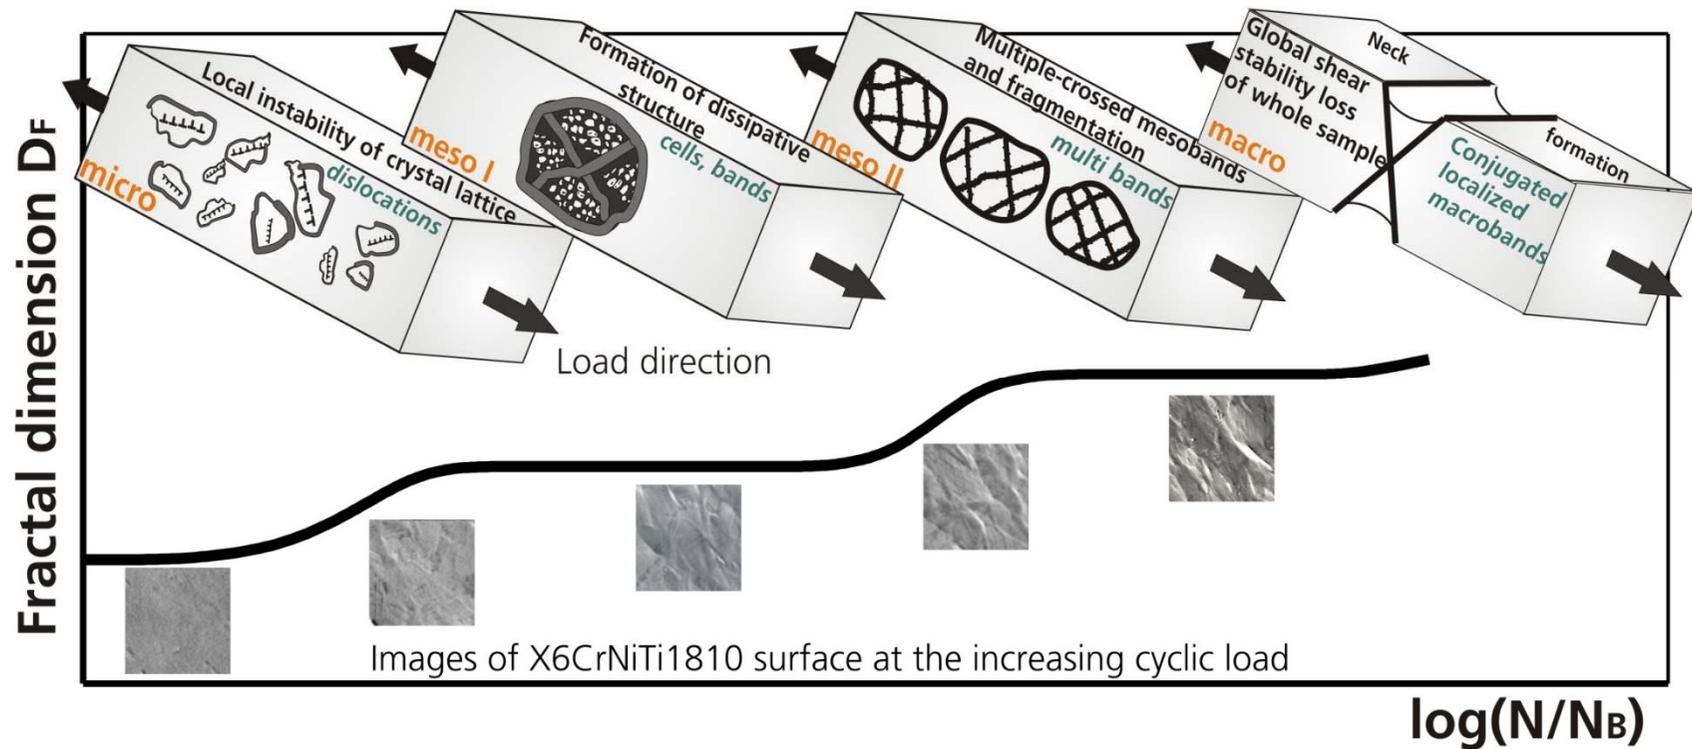
Scale levels of shear stability loss in deformed solid

N - cycles number , N_B - number of the cycles till the sample break

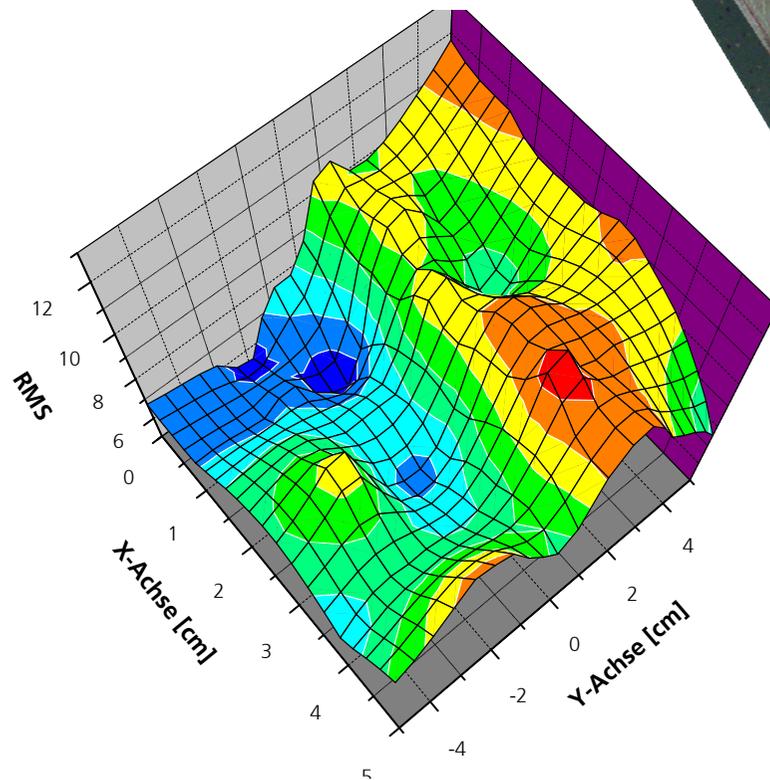
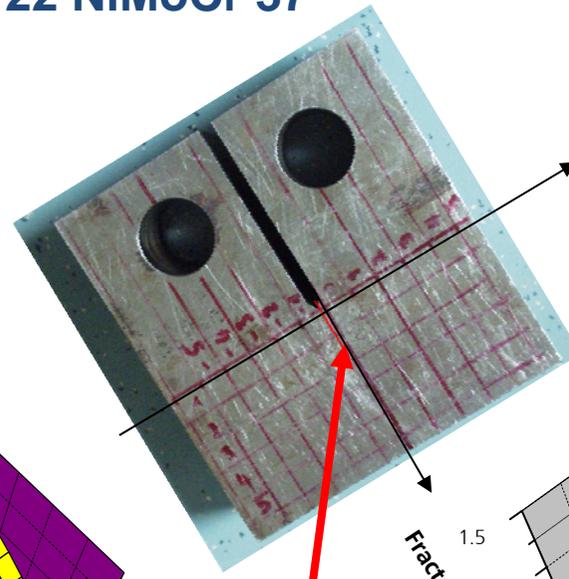
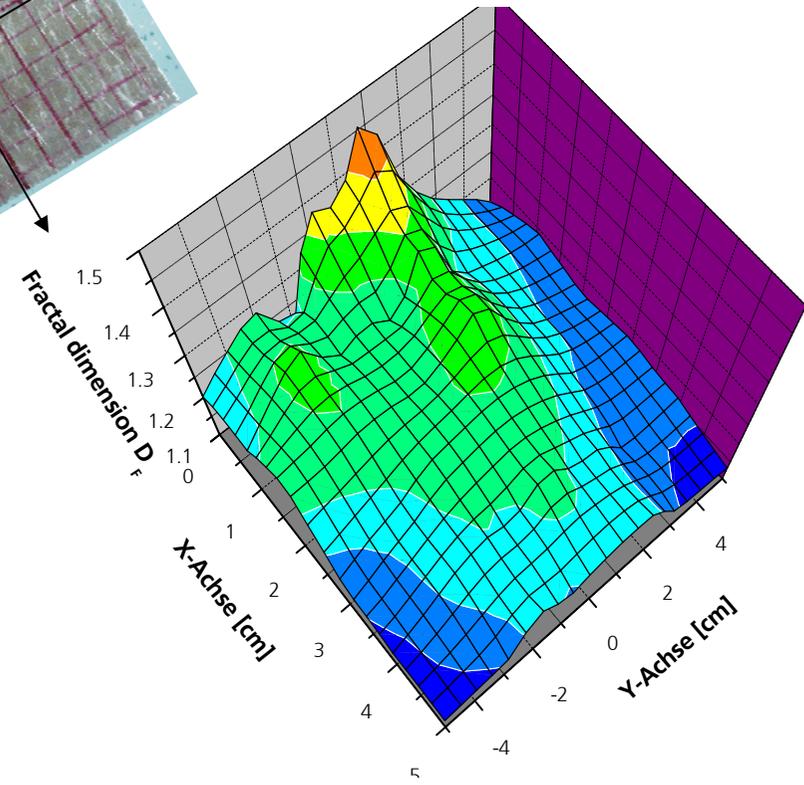
Barkhausen Map of Fatigued CT Sample

22 NiMoCr 37

RMS ~ Residual Stress

Fractal Dimension

Crack

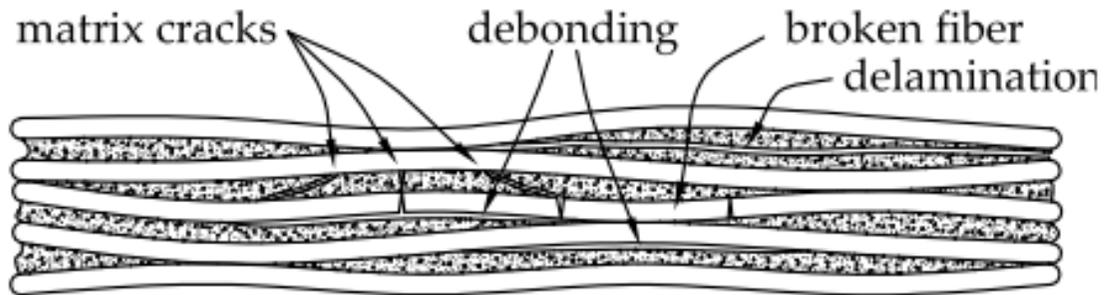
matrix crack, broken fibers, debonding and delamination

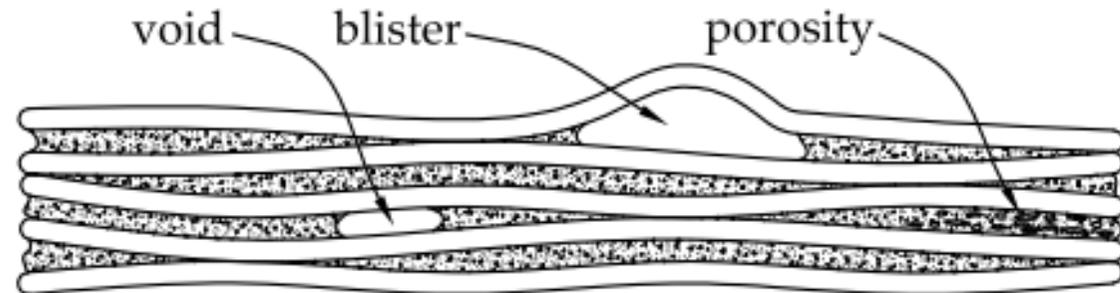
when air gets trapped between layers

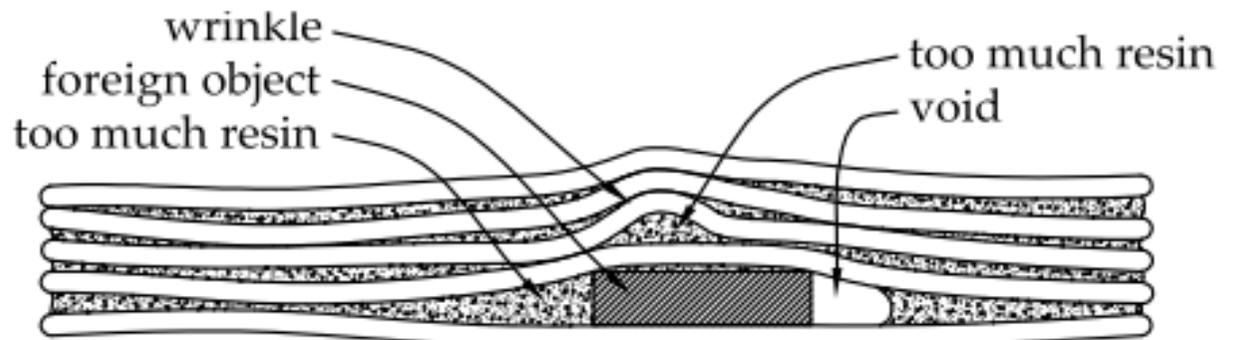
inclusion and wrinkle

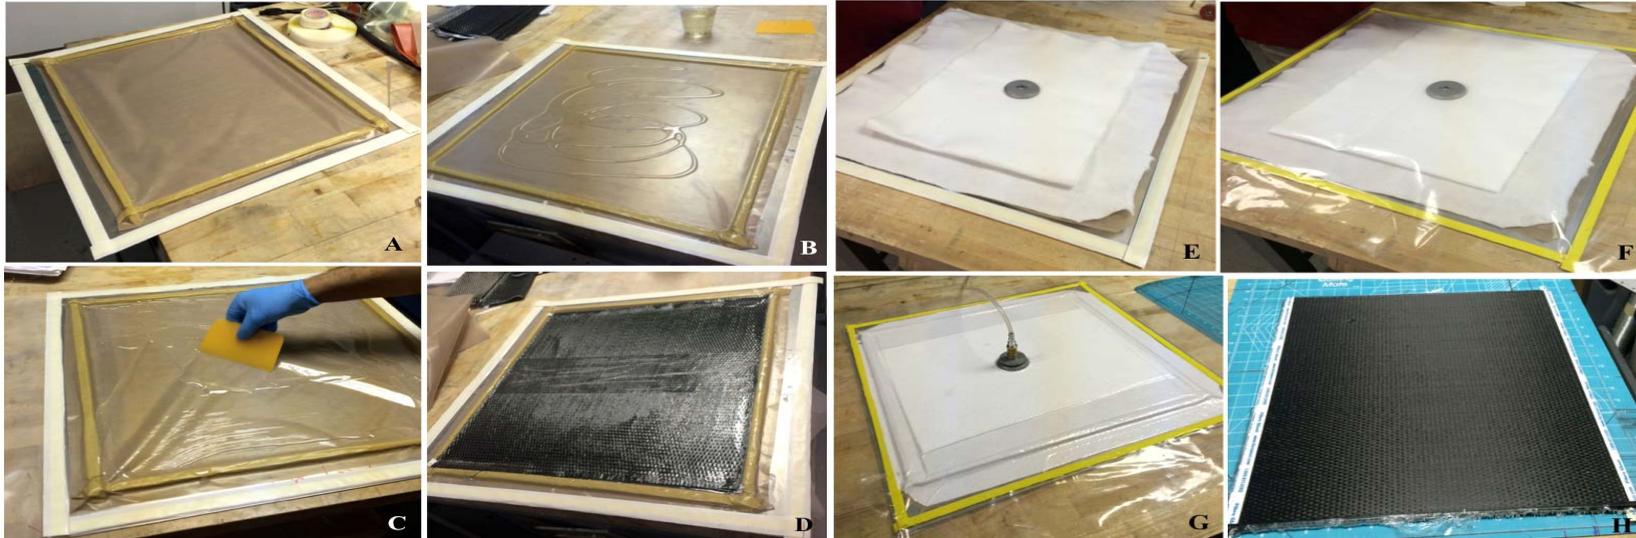
Approach: Panel Fabrication (Vacuum Bagging)

Hand laying up steps: (A) dam structure (B) Resin laying up (C) Resin distributing (D) Placing the Teflon insert at the panel mid-plane; on top of four layers (E) Placing breather (F) Placing vacuum bag and fiber and resin ready to be subjected to vacuum (G) **Applying vacuum bagging for 24 hours** (G) Panels after vacuum bagging-hard (H) Final shape of panels after being cured and ready to be cut.

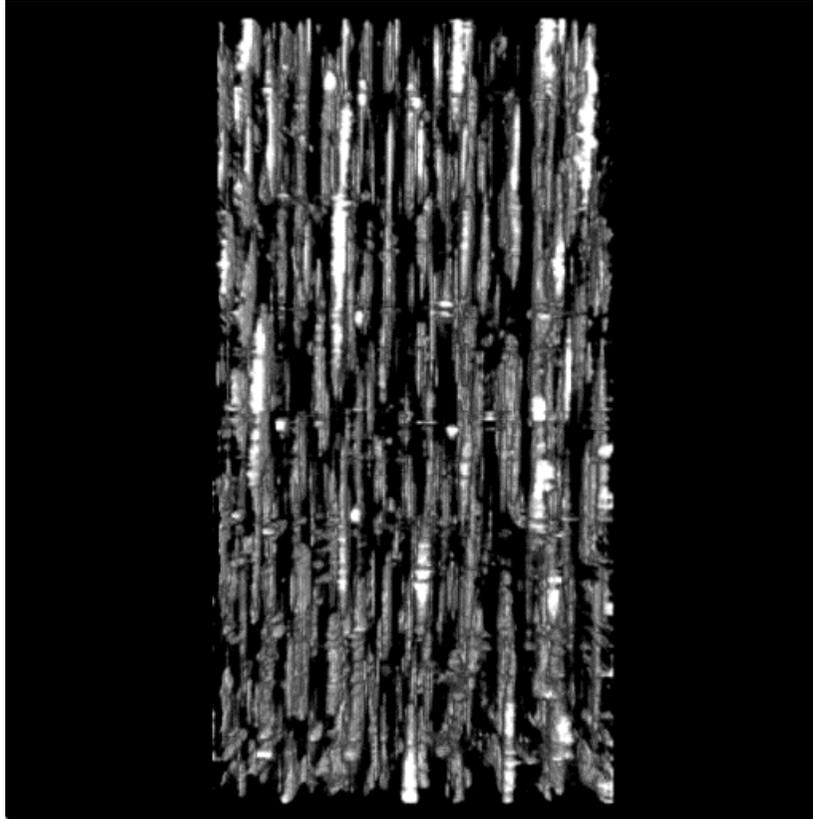
X-ray Laminography 3D Reconstruction

- What we see are a lot of artifacts for instance
- Imaging techniques provide a lot of information
- Extracting the relevant information is the challenge
